RESULTS OF A TELEMETERING INVESTIGATION
OF PARACHUTE OPENING ALTITUDE OF THE
UNIVERSAL PARACHUTE PACK ON THE MINE CASE MK 36

NAVORD Report 4040

22 August 1955

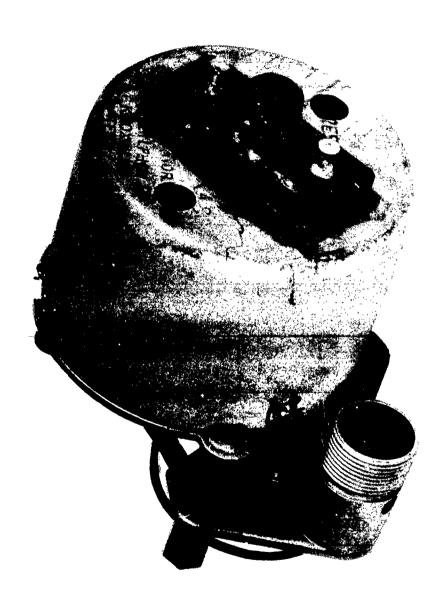
- 25. A vibration gage was attached to the pressure switch as shown in Figure 6. This gage consisted of a Meissner type 25009 adjustable RF coil. The iron slug of this coil was cemented to the top of the bellows and the coil portion was mounted on the cover of the pressure switch. Any motion of the bellows would change the relative position of the slug in the coil and thus change the coil inductance. The coil was incorporated into an oscillator at 70 KC. This formed a fourth channel of the system. No temperature gages were included in these mines.

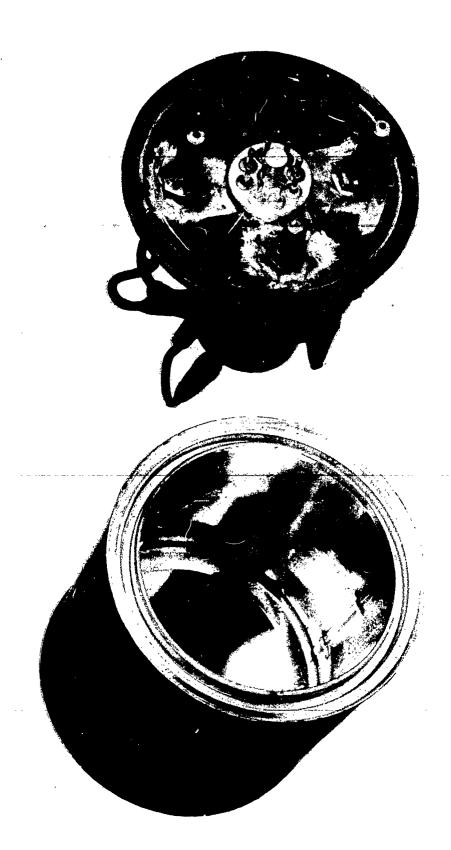
- 35. The pressure gages were Bendix Aviation Company Type TTP-2A and Type TTP-17. These are shown as mounted for the last two drops in Figures 11 and 12. The tuning condenser for each subcarrier oscillator was included in this assembly. The reference pressure vessel consisted of only the copper tube joining the two gages. This probably should be increased in volume on any future drops. The whole assembly was dipped in ceresin wax as shown in Figure 12. When the can is filled with an ice water mixture and packed in rock wool, it will maintain constant temperature for from four to six hours.

FIG. 11 PRESSURE GAGE ASSEMBLY

- 24. Two mine cases were equipped with fins and telemetering equipment. Pressure gages were arranged as shown in Figure 5, with the same ranges as shown there. The gages were mounted in a small can and waxed as shown in Figures 11 and 12. The can was filled with a mixture of ice and water and then packed in rock wool for thermal insulation. These precautions were taken to insure that the pressure gages and pressure reference vessel would be at exactly 32° F. for several hours.

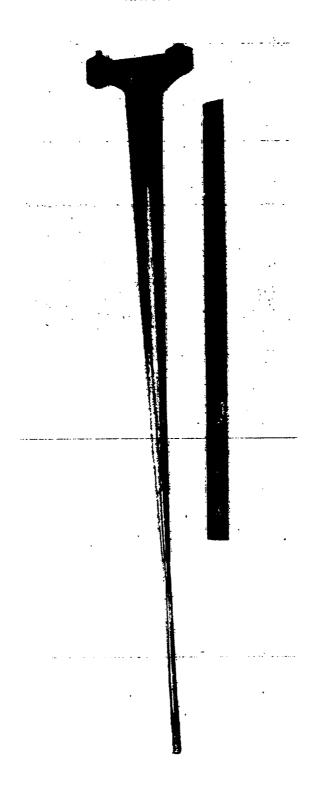
- 36. The transmitting antenna is shown in Figures 13 and 14. It is three-fourths wavelength long and is driven at the base. The large thick washers visible in the photograph are made of polystyrene and form the insulators for mounting. The antenna is mounted in the center of the front plate of the mine. The design of the antenna insofar as its function as a static tube is concerned is essentially according to National Advisory Committee on Aeronautics specifications. The hose connection for the static tube is visible in Figure 14.

FIG. 13 ANTENNA STATIC TUBE
